NORTH LONDON WASTE AUTHORITY NORTH LONDON HEAT AND POWER PROJECT

ENVIRONMENTAL STATEMENT: VOLUME 3 APPENDICES

VISUAL ASSESSMENT METHODOLOGY

VOLUME 3 APPENDIX 1.1

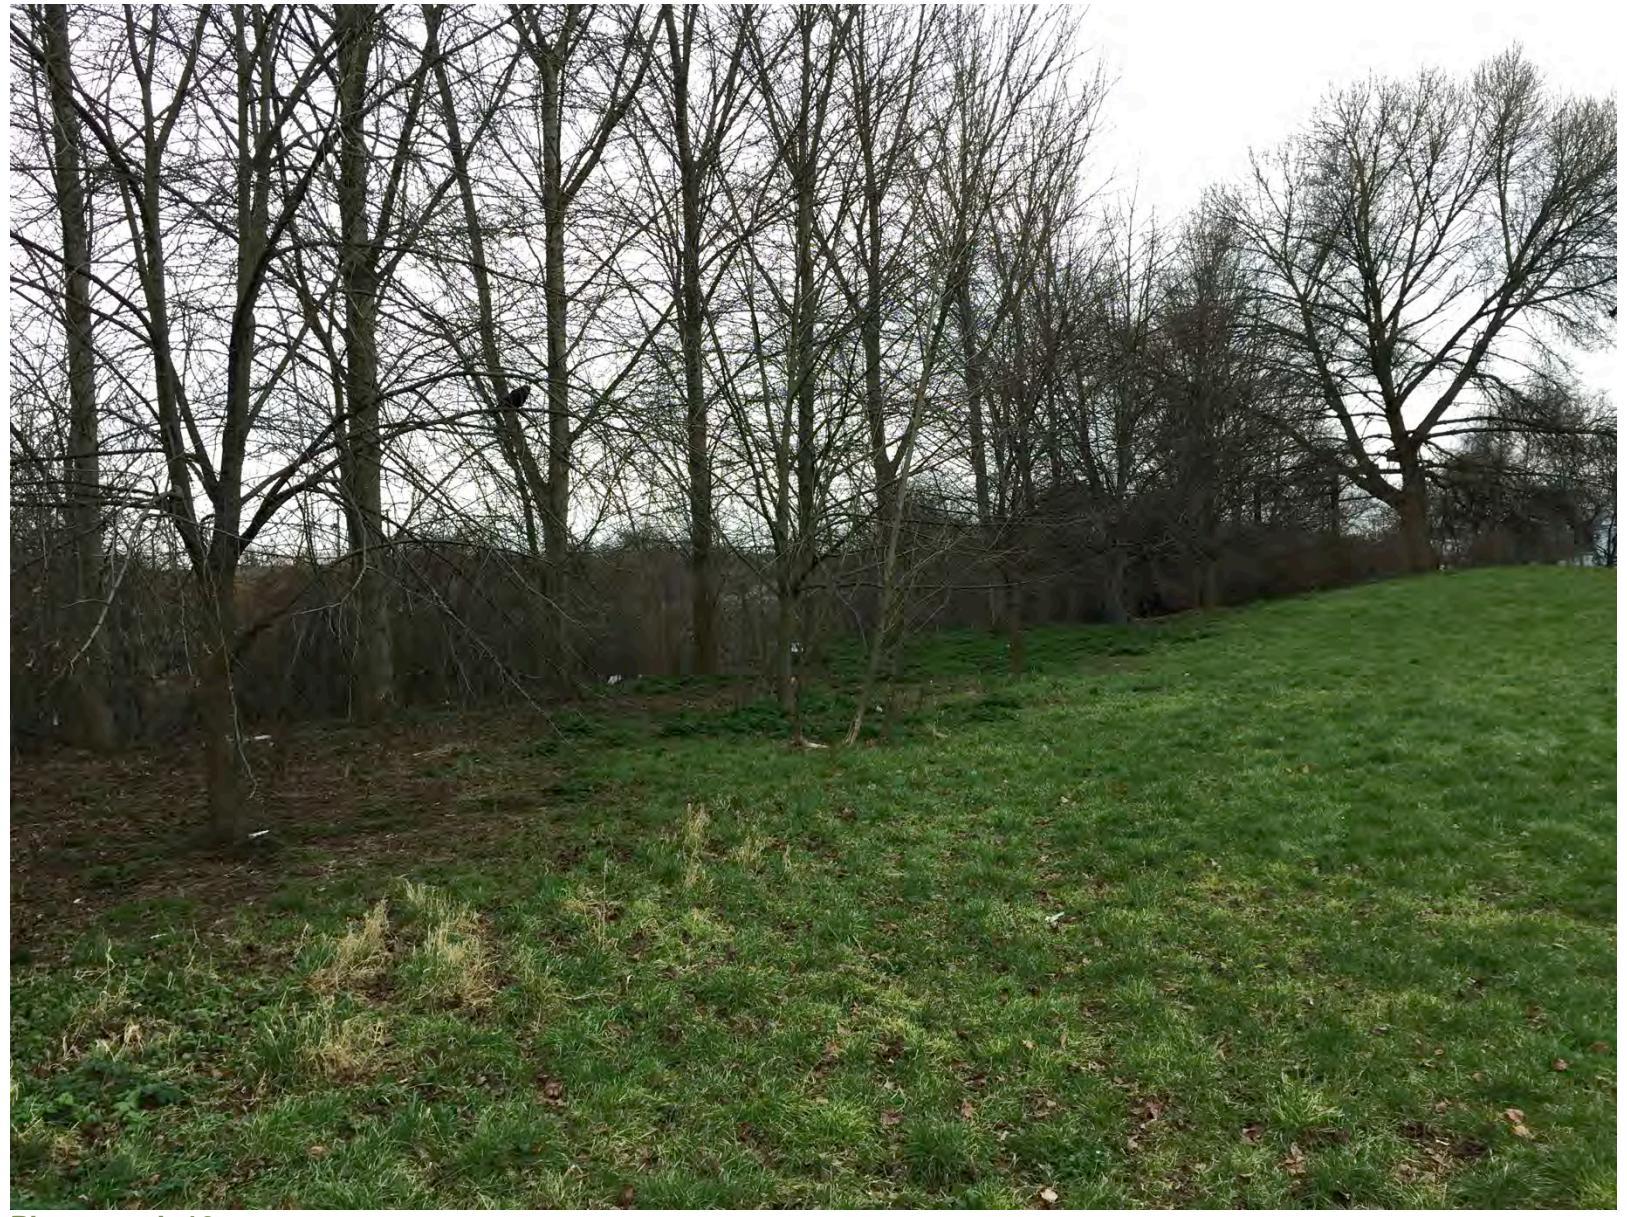
Photograph 12: Looking South-east towards trees 95-81 (background), 123-128 (foreground) (read left to right) and tree 48 on the right side of the photograph

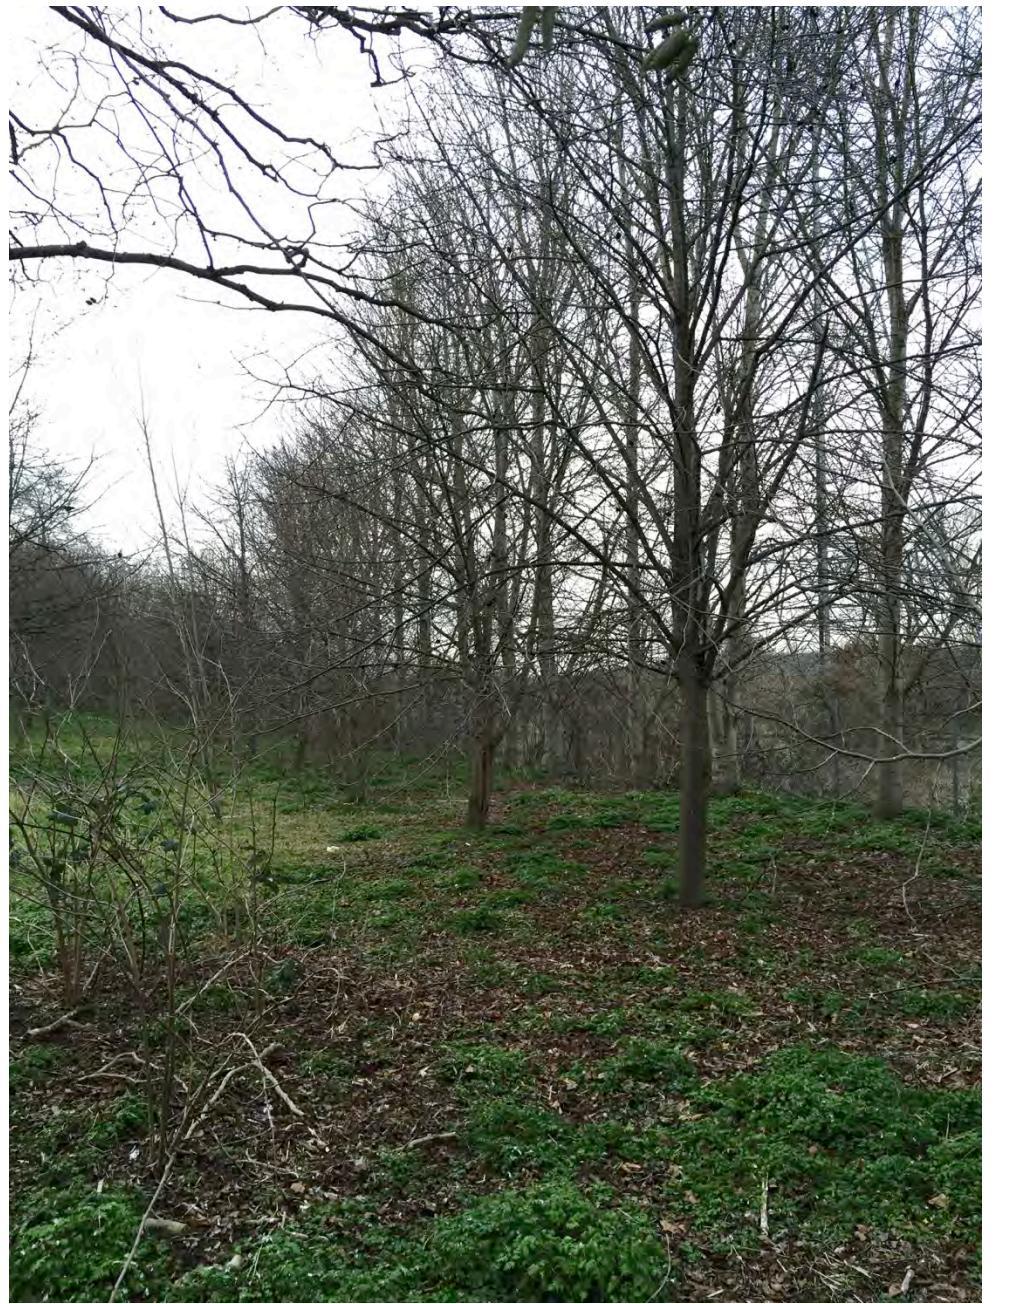
Photograph 13: Looking North-east towards trees 112-100 (background) and 114-121(foreground) (read left to right)

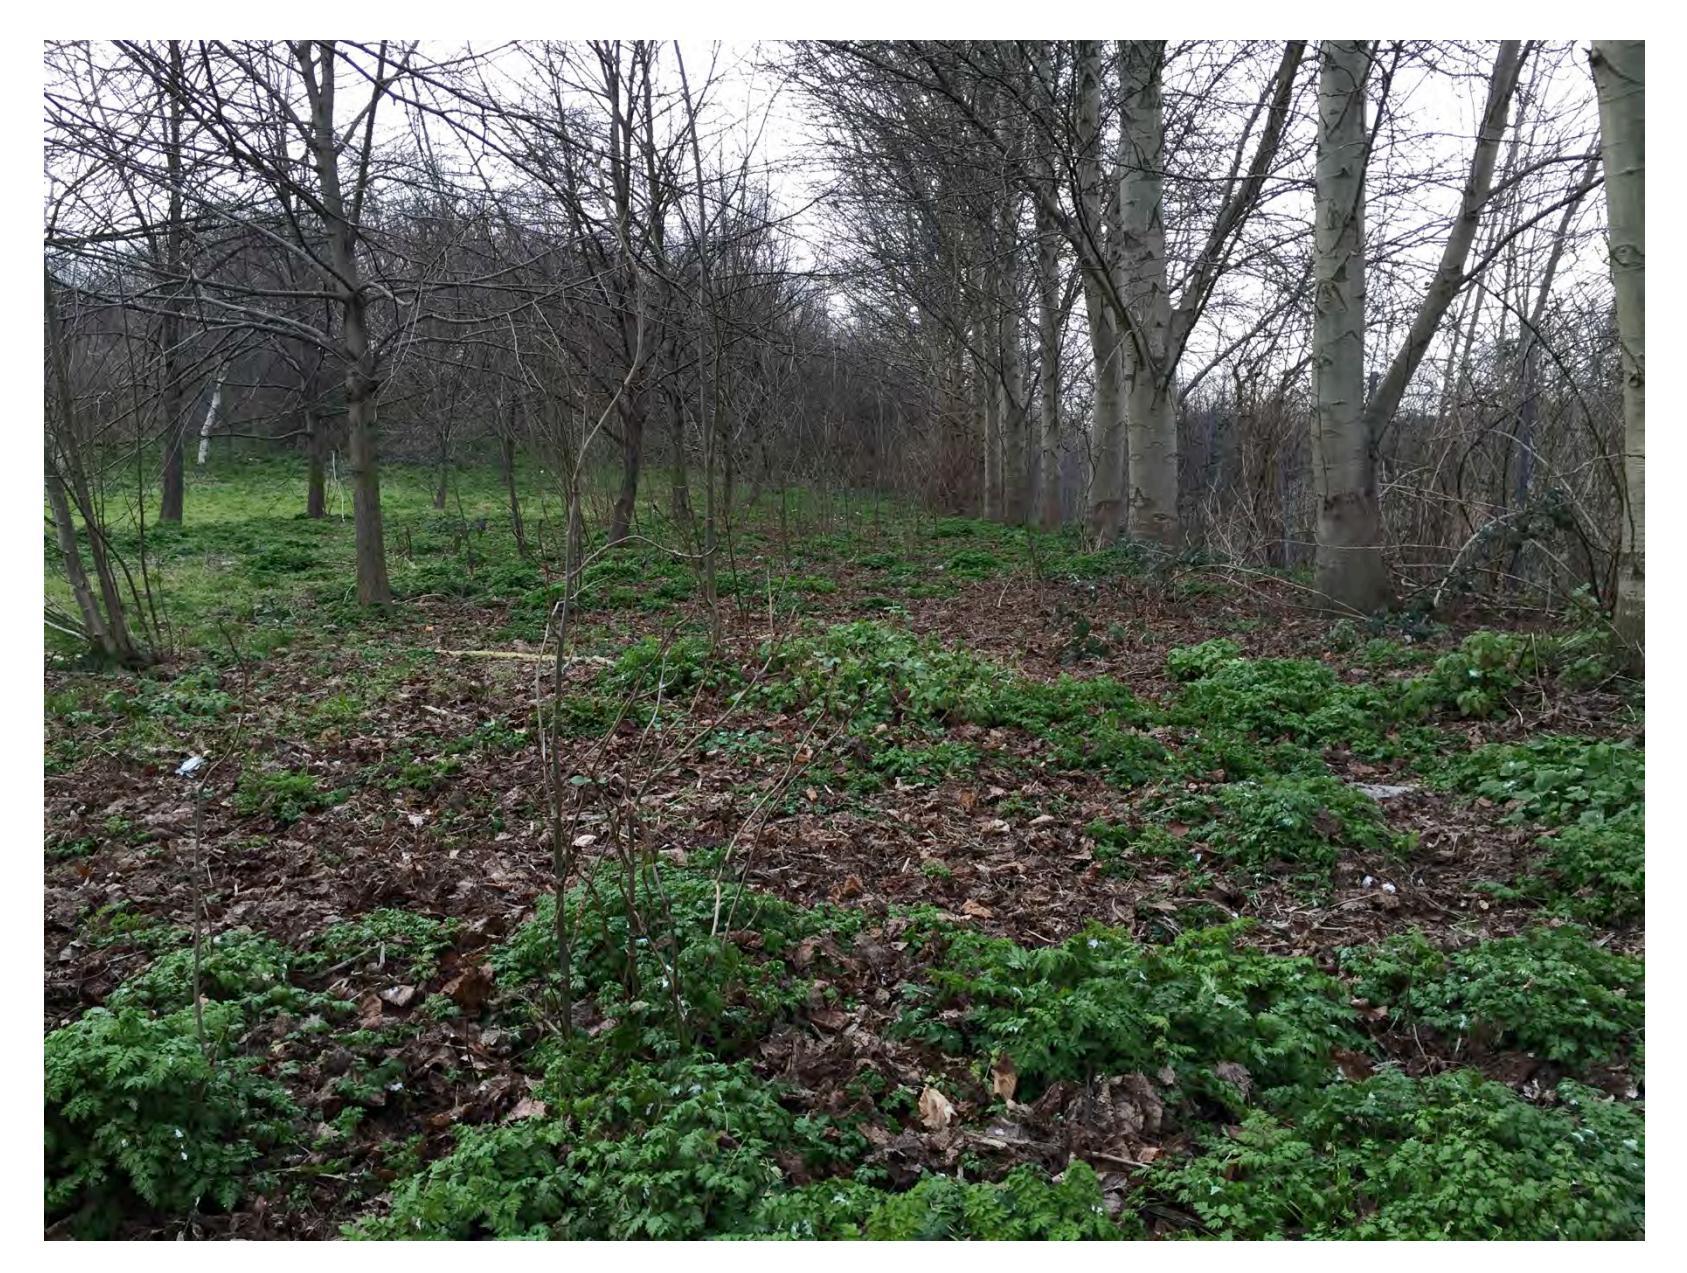
Photograph 14: Looking northwards between trees 119-114 (left side of photograph) and 100-112 (right side of photograph) (read front to back)

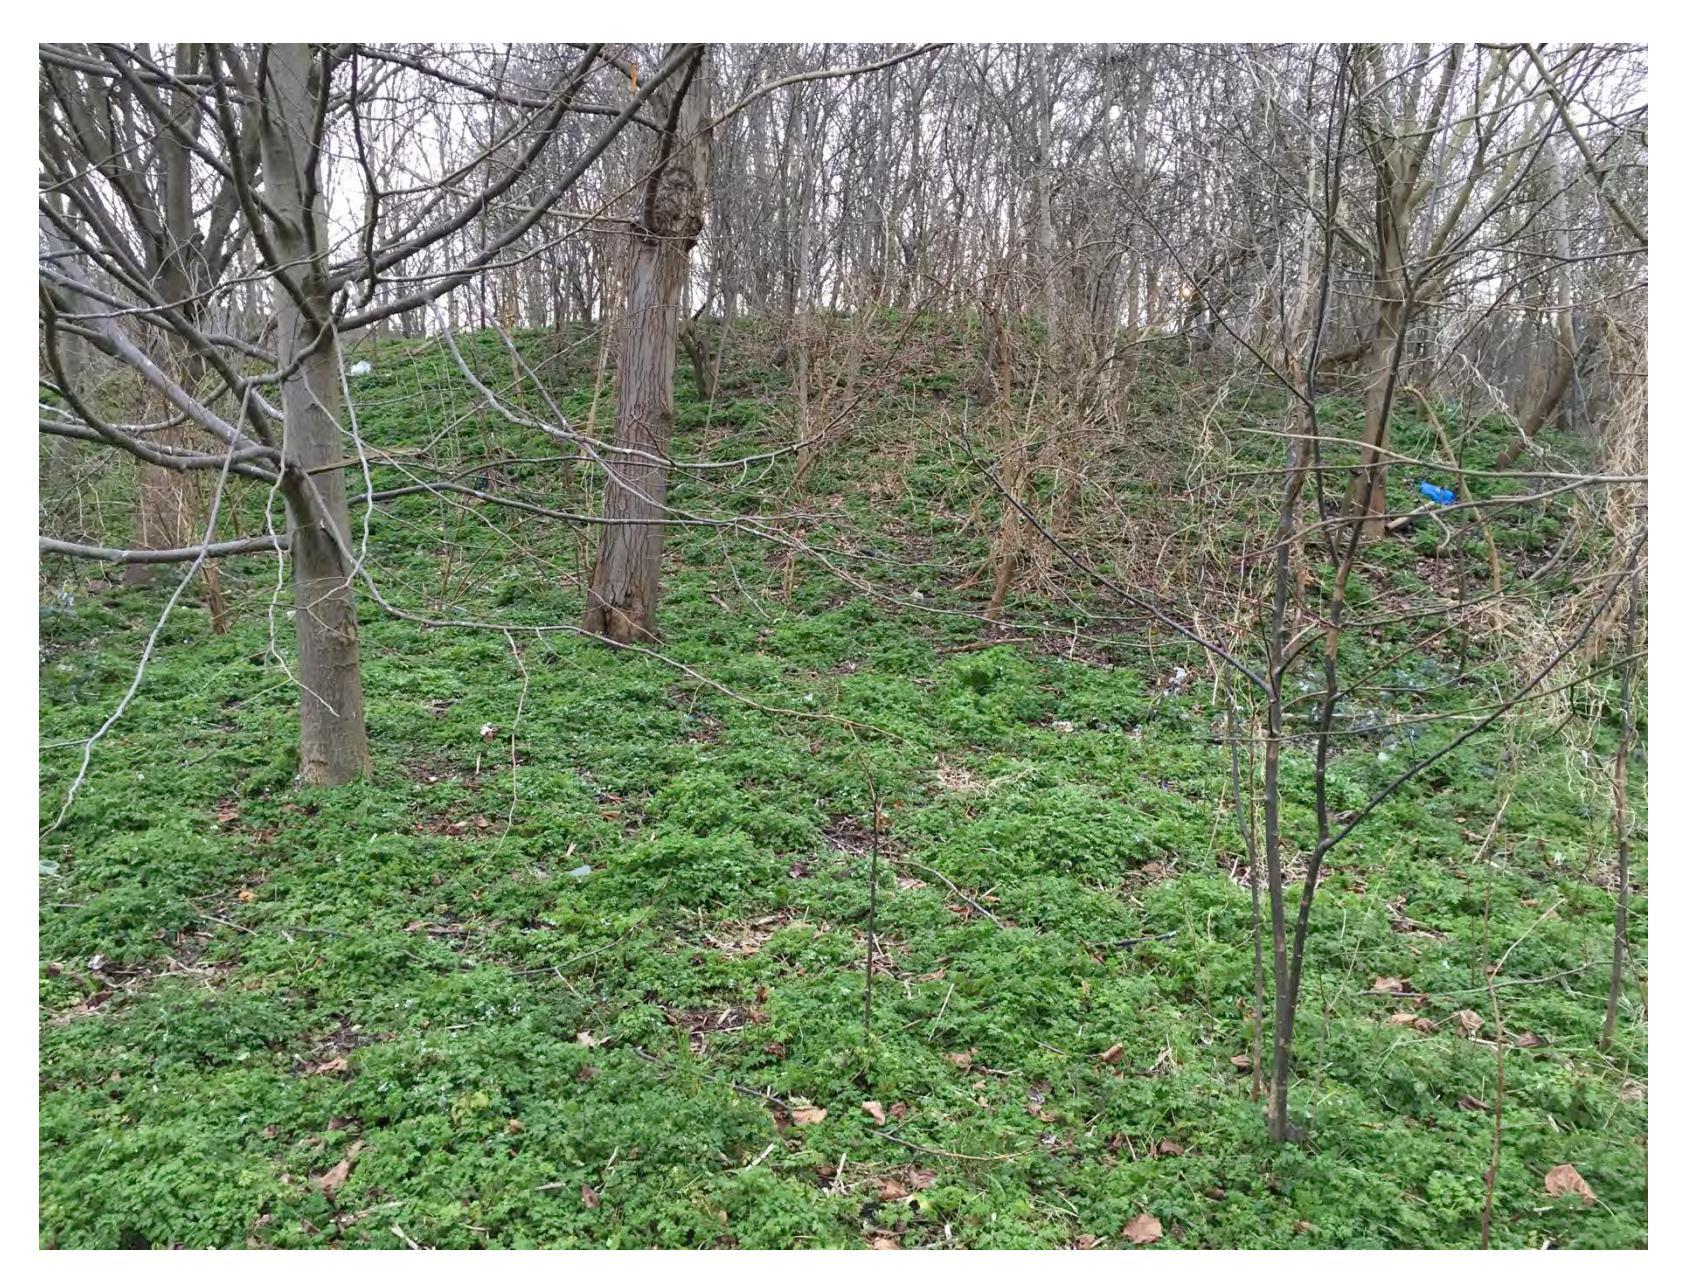
Photograph 15: Looking North into Group 17, trees 134, 135 and 136 are the more dominant trees on the left side of the photograph

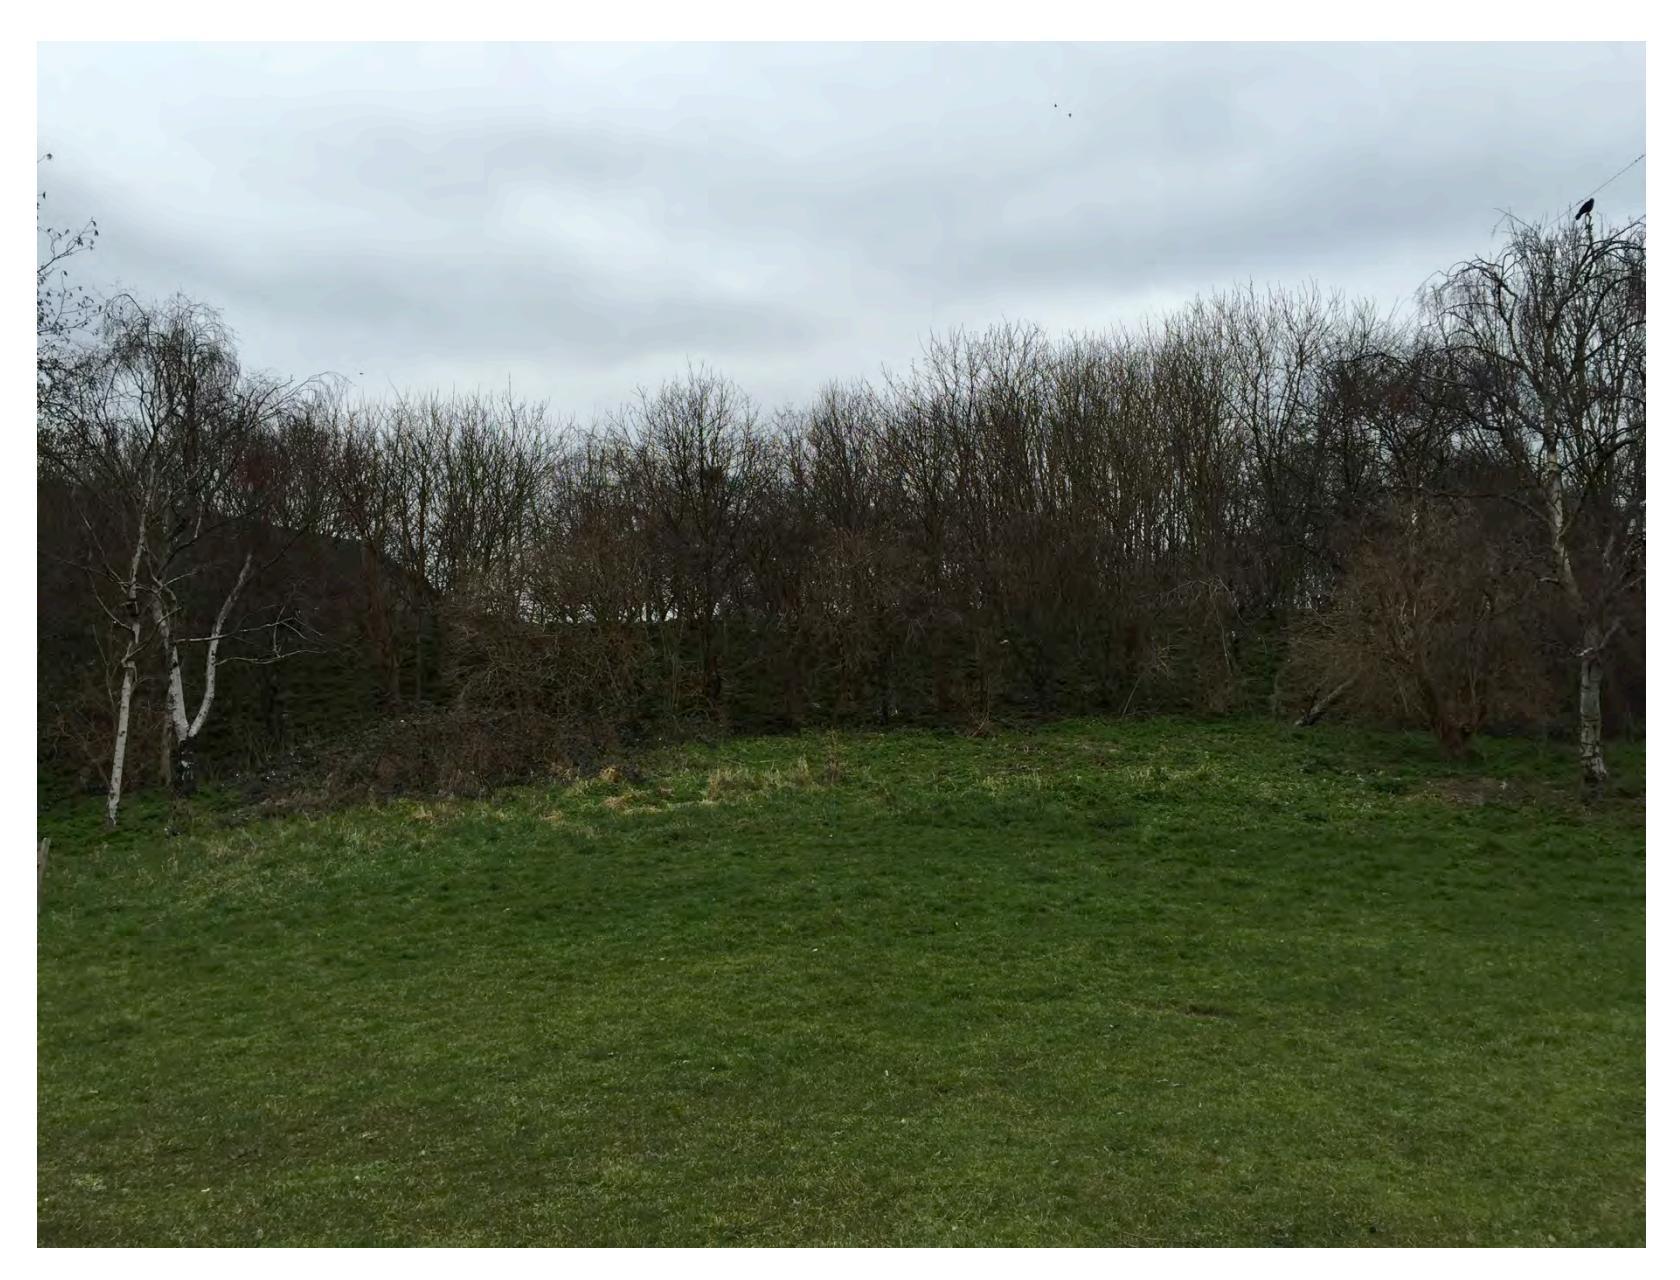
Photograph 21: Looking North to Group 17, trees 138 and 139 are on the right side of the photograph

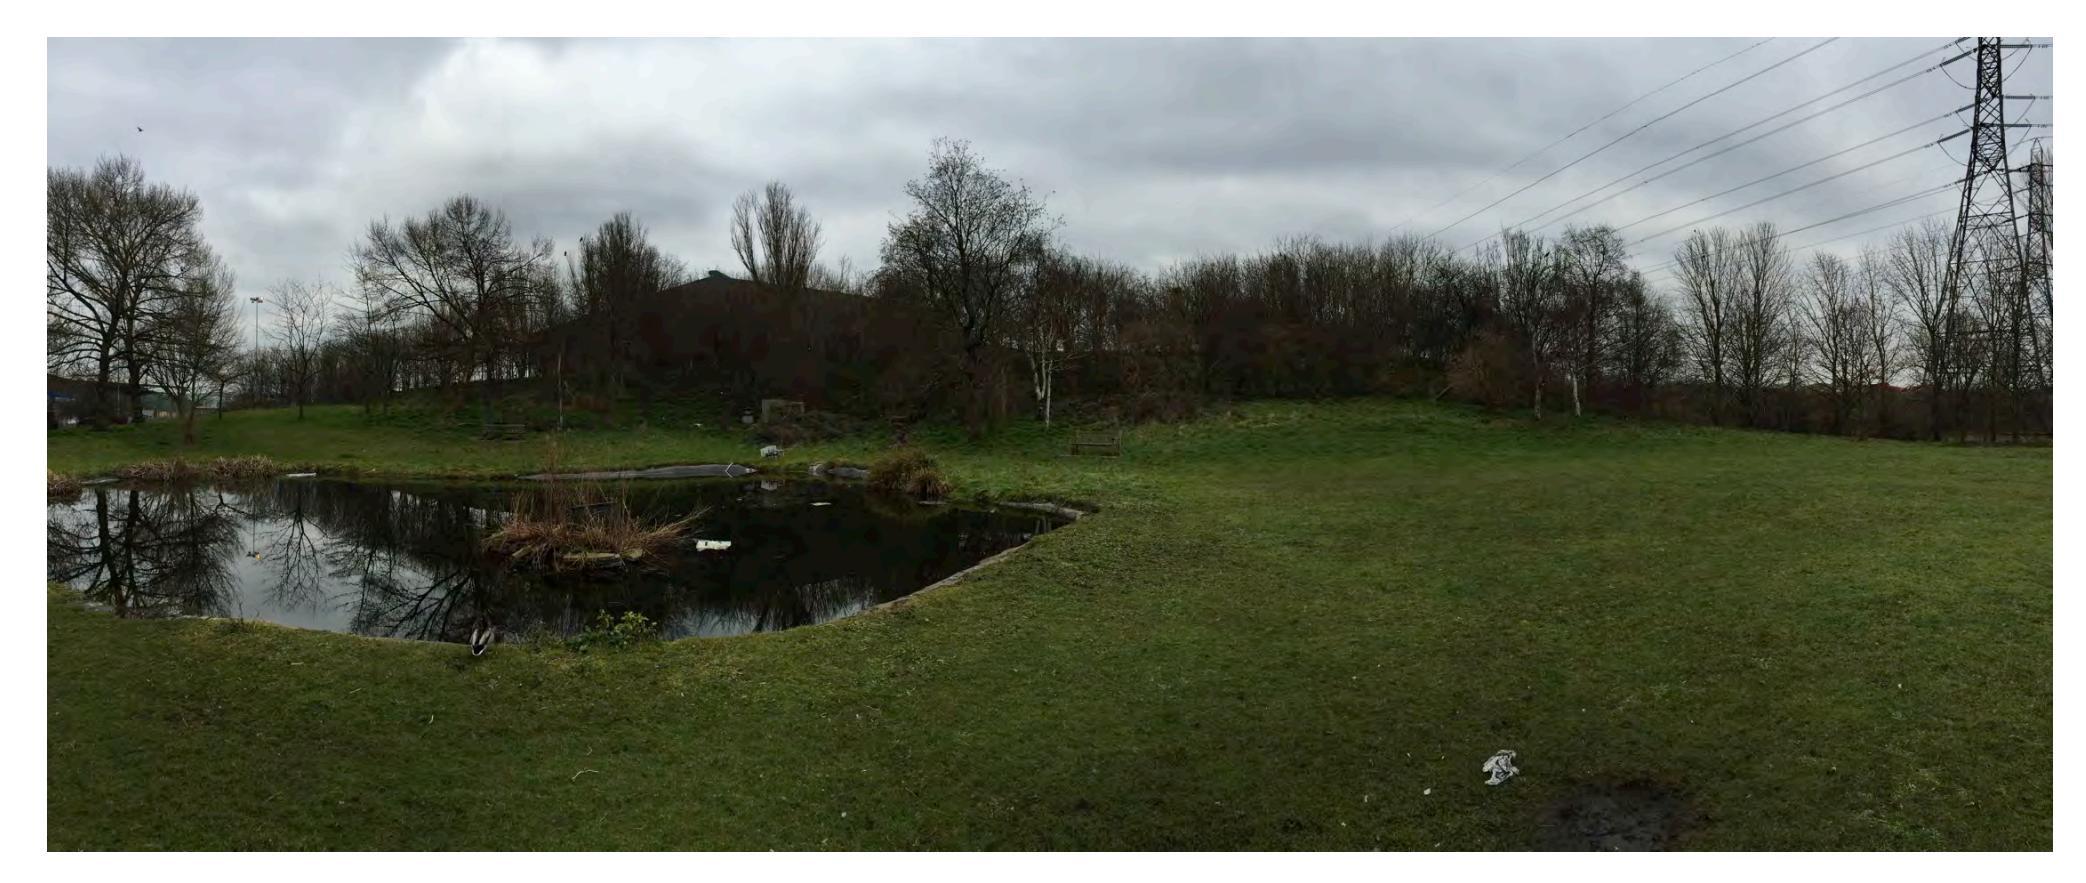
Photograph 22: Looking North to Group 17, trees 59-64 on the left hand of the photograph, trees 105-117 and 130-143 on the right hand side of the photograph

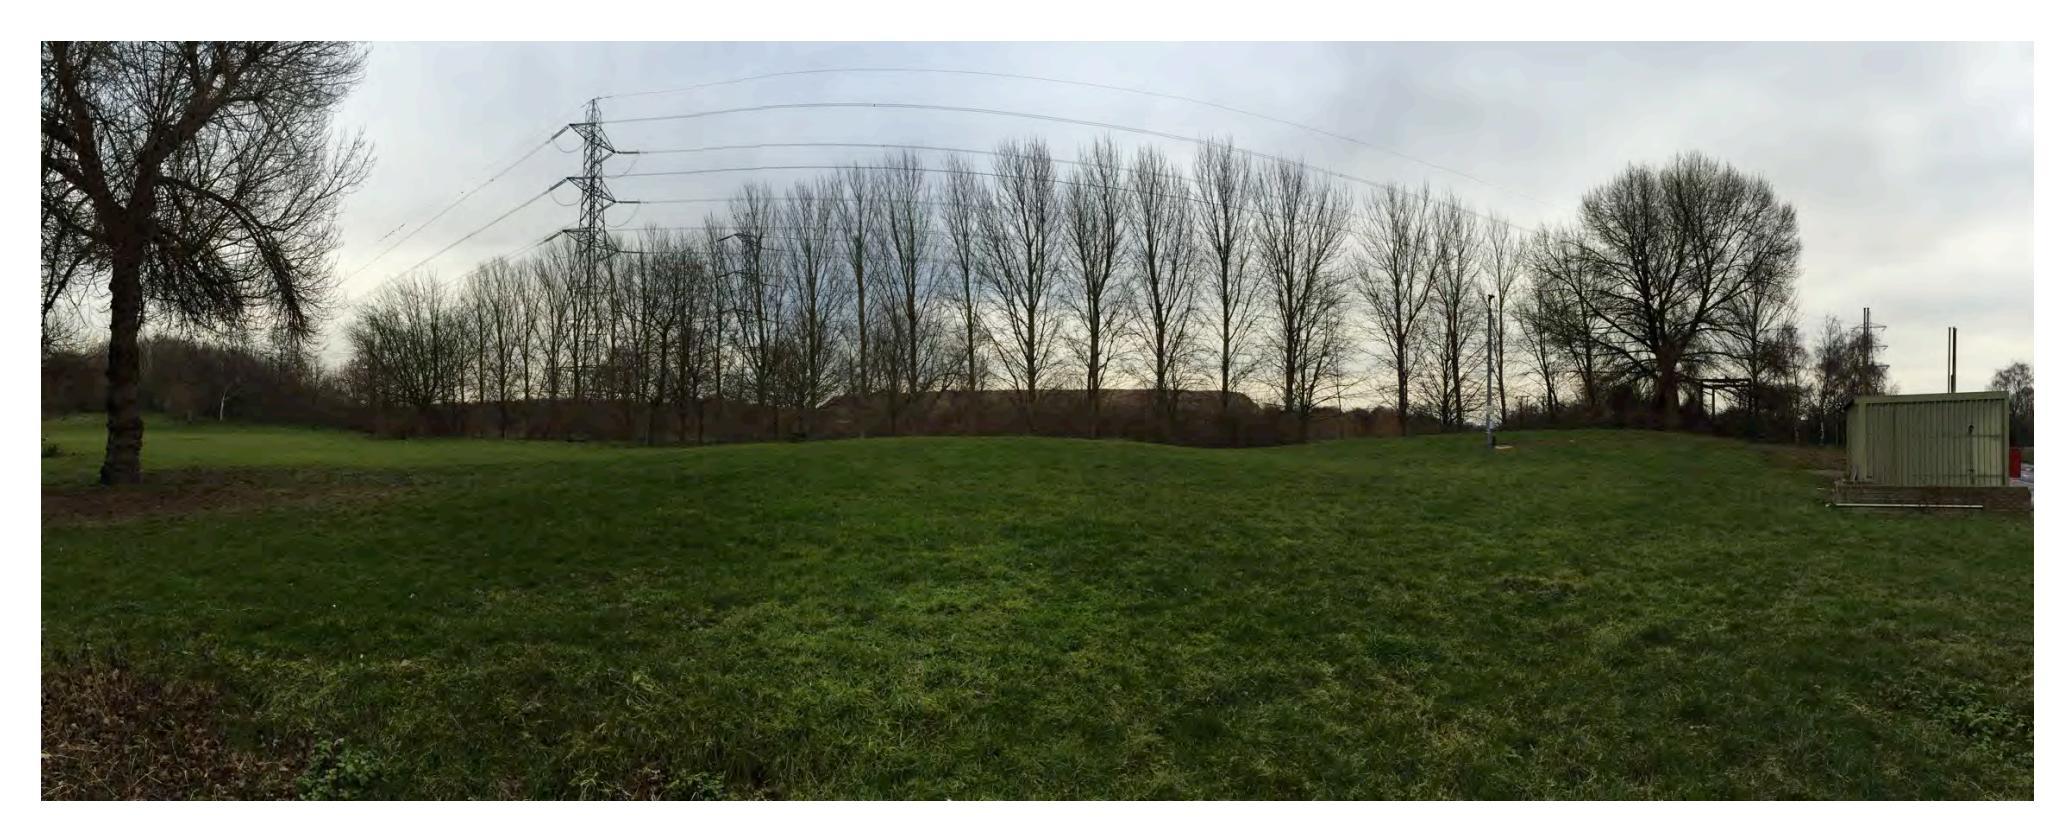
Photograph 23:

Looking East to trees 113-81 (left to right) with trees 114-128 (left to right) and tree 51 standing in front with canopies just visible, tree 48 stands to the right hand side and tree 52 stands on the left hand side of the photograph.

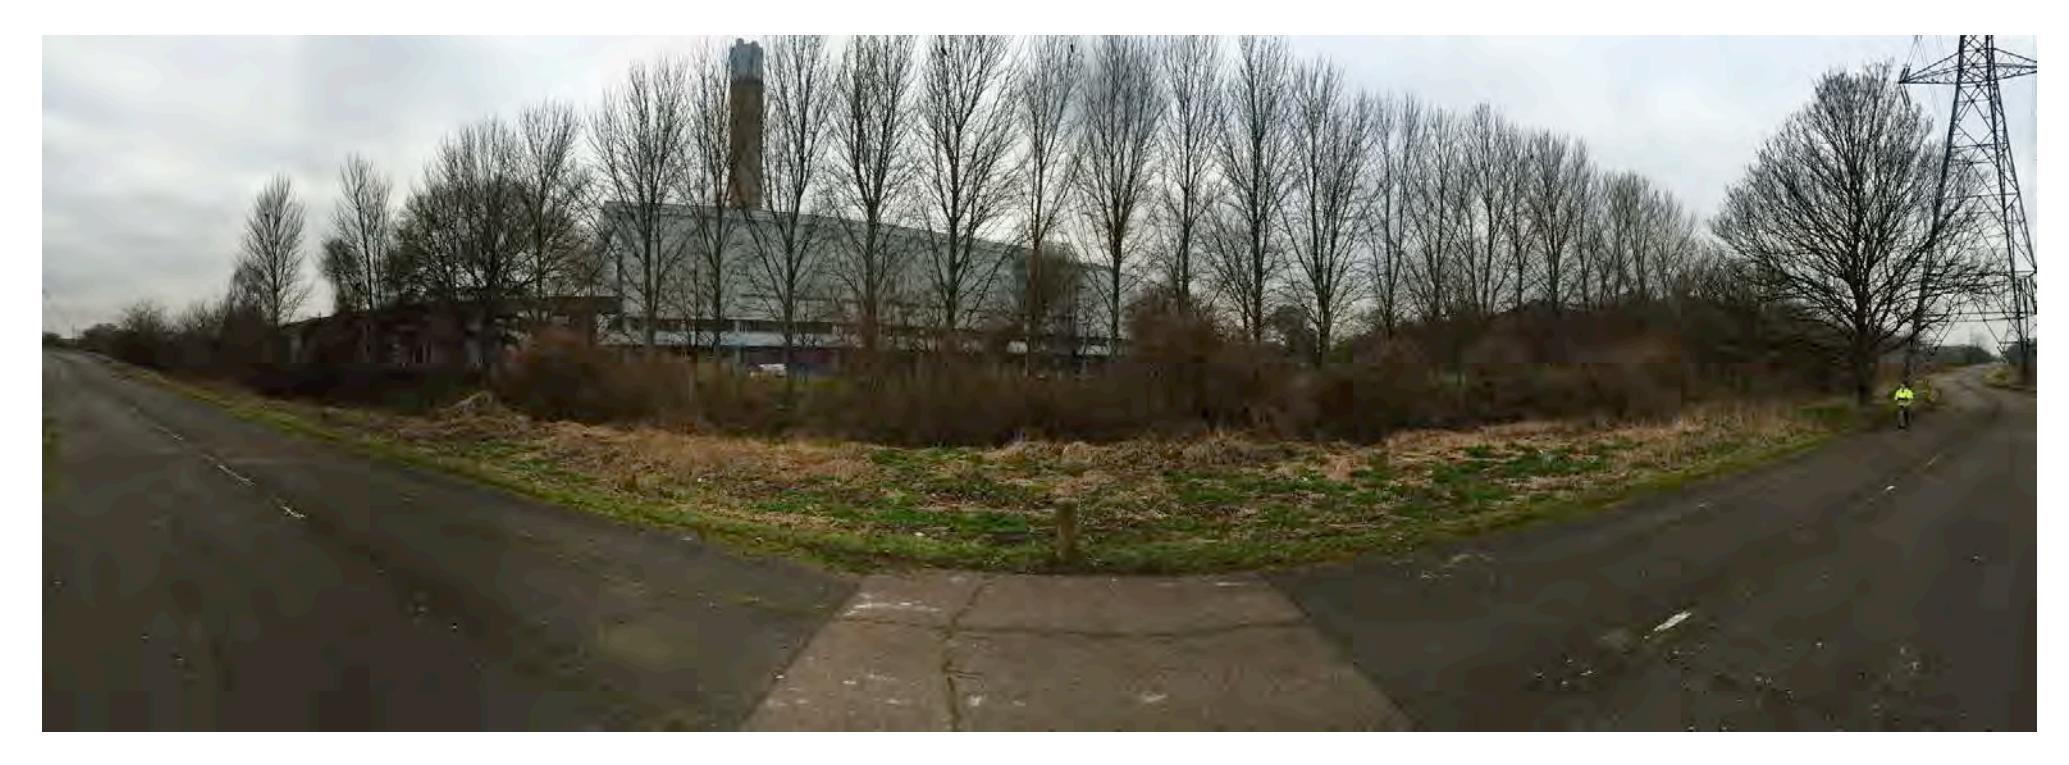
Photograph 24:

Looking East to trees 75-113 (left to right), tree 150 is on the right hand side of the photograph and tree 48 stands to the left hand side of the photograph.

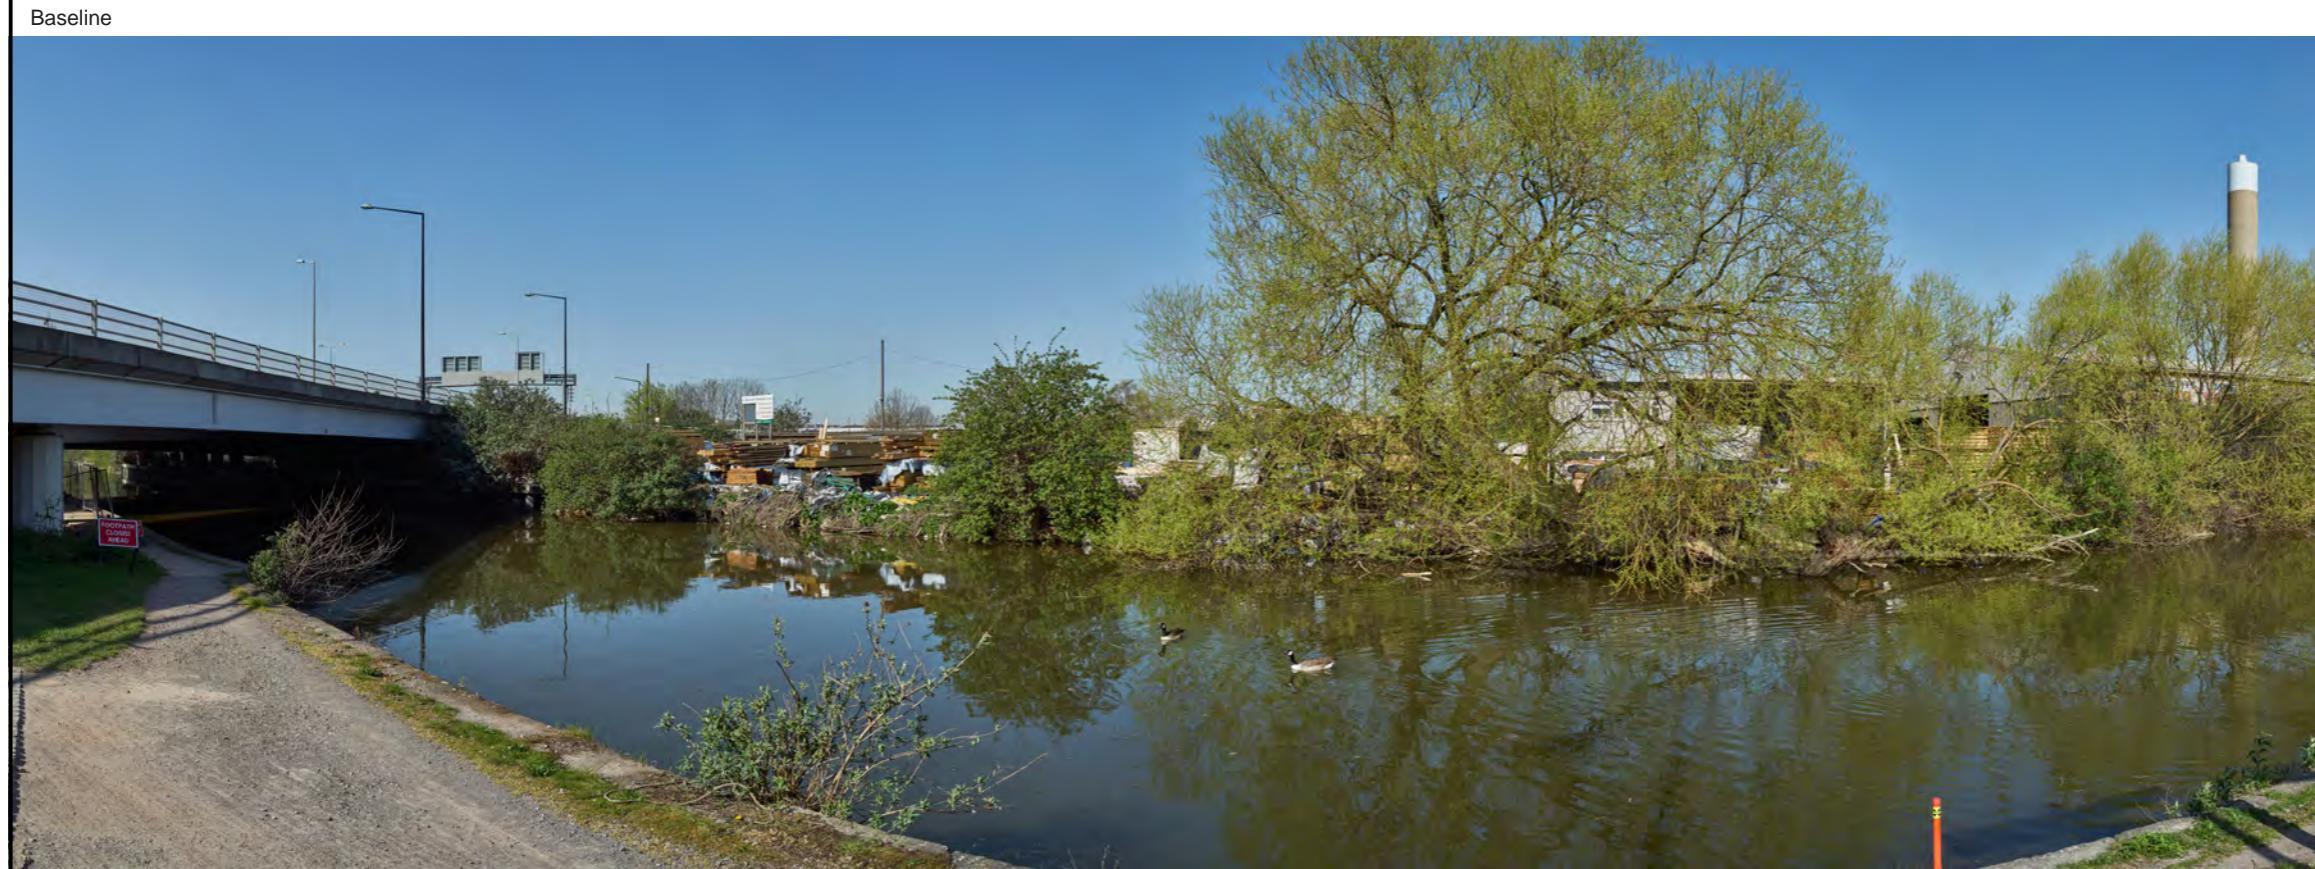
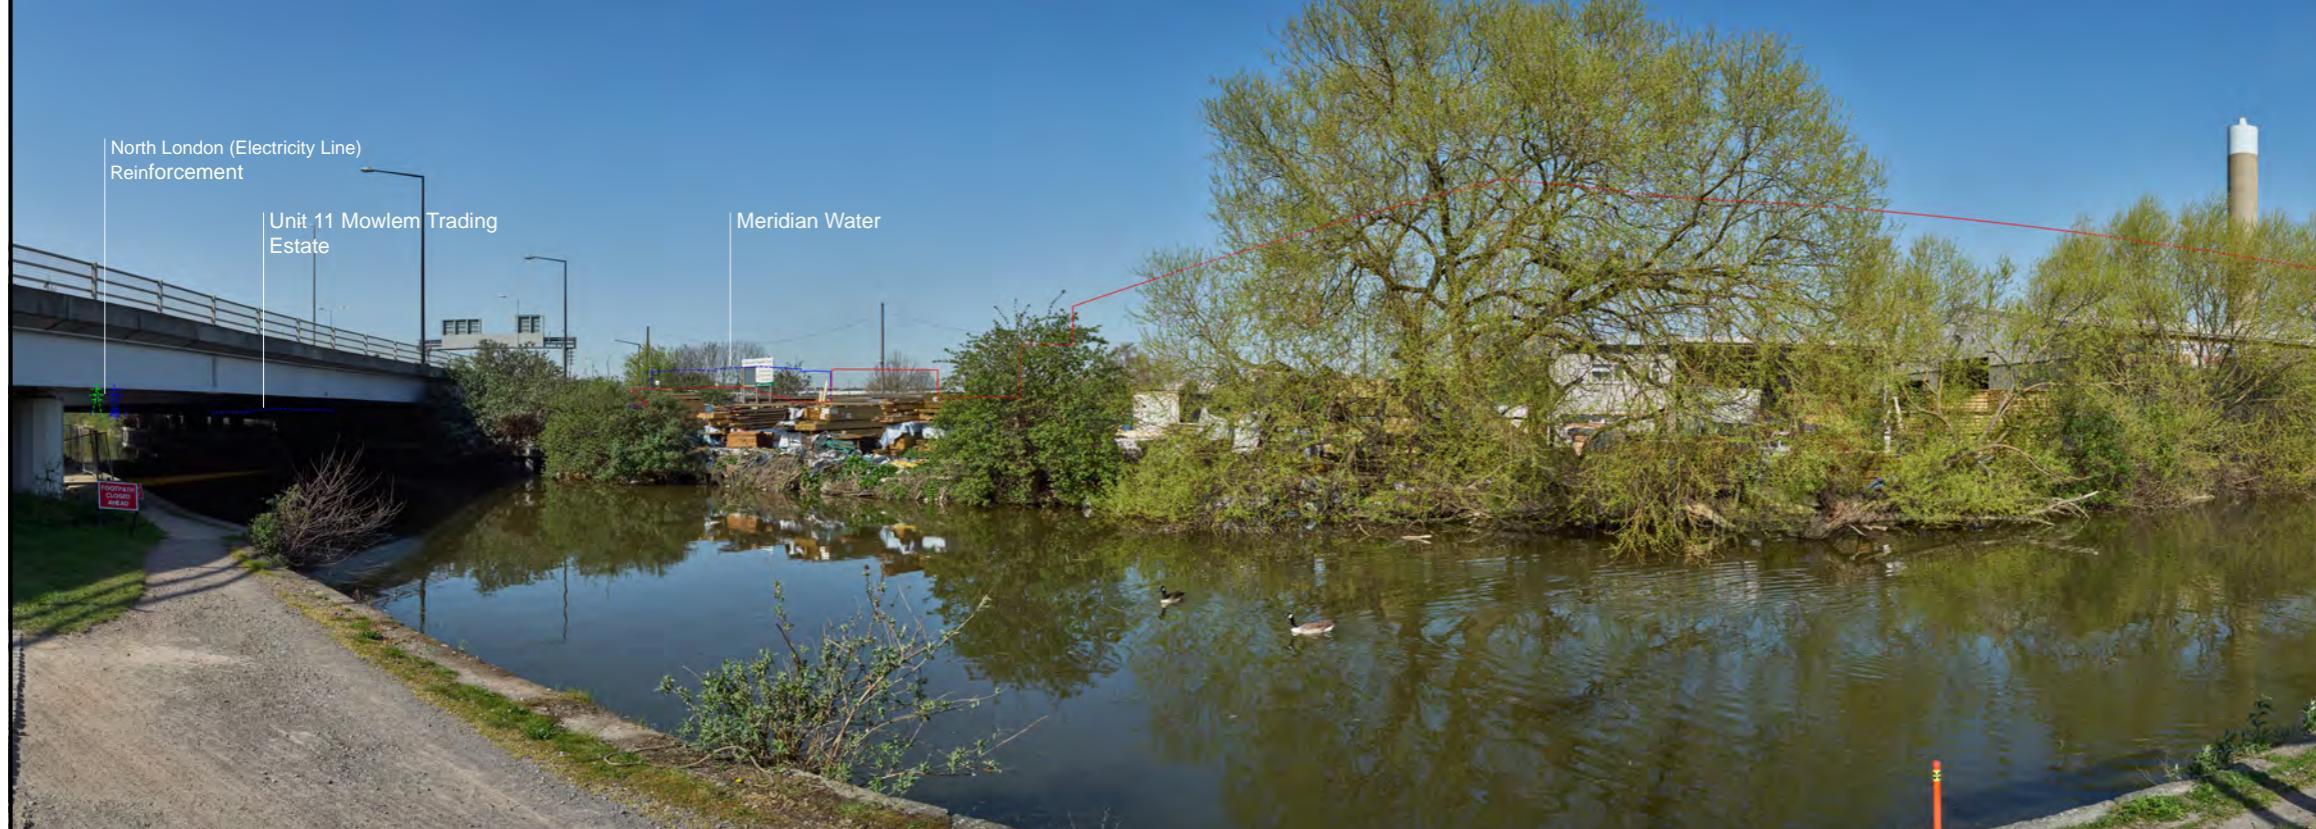
gure Number 8.1.1 Figure Name Viewpoint 1 Existing situation and Application Site with existing EfW, cumulative and future baseline

Wireline of Proposed Schemes with existing EfW facility

Technical Information Grid Ref.: 535850, 192349

Date taken: 15/04/15

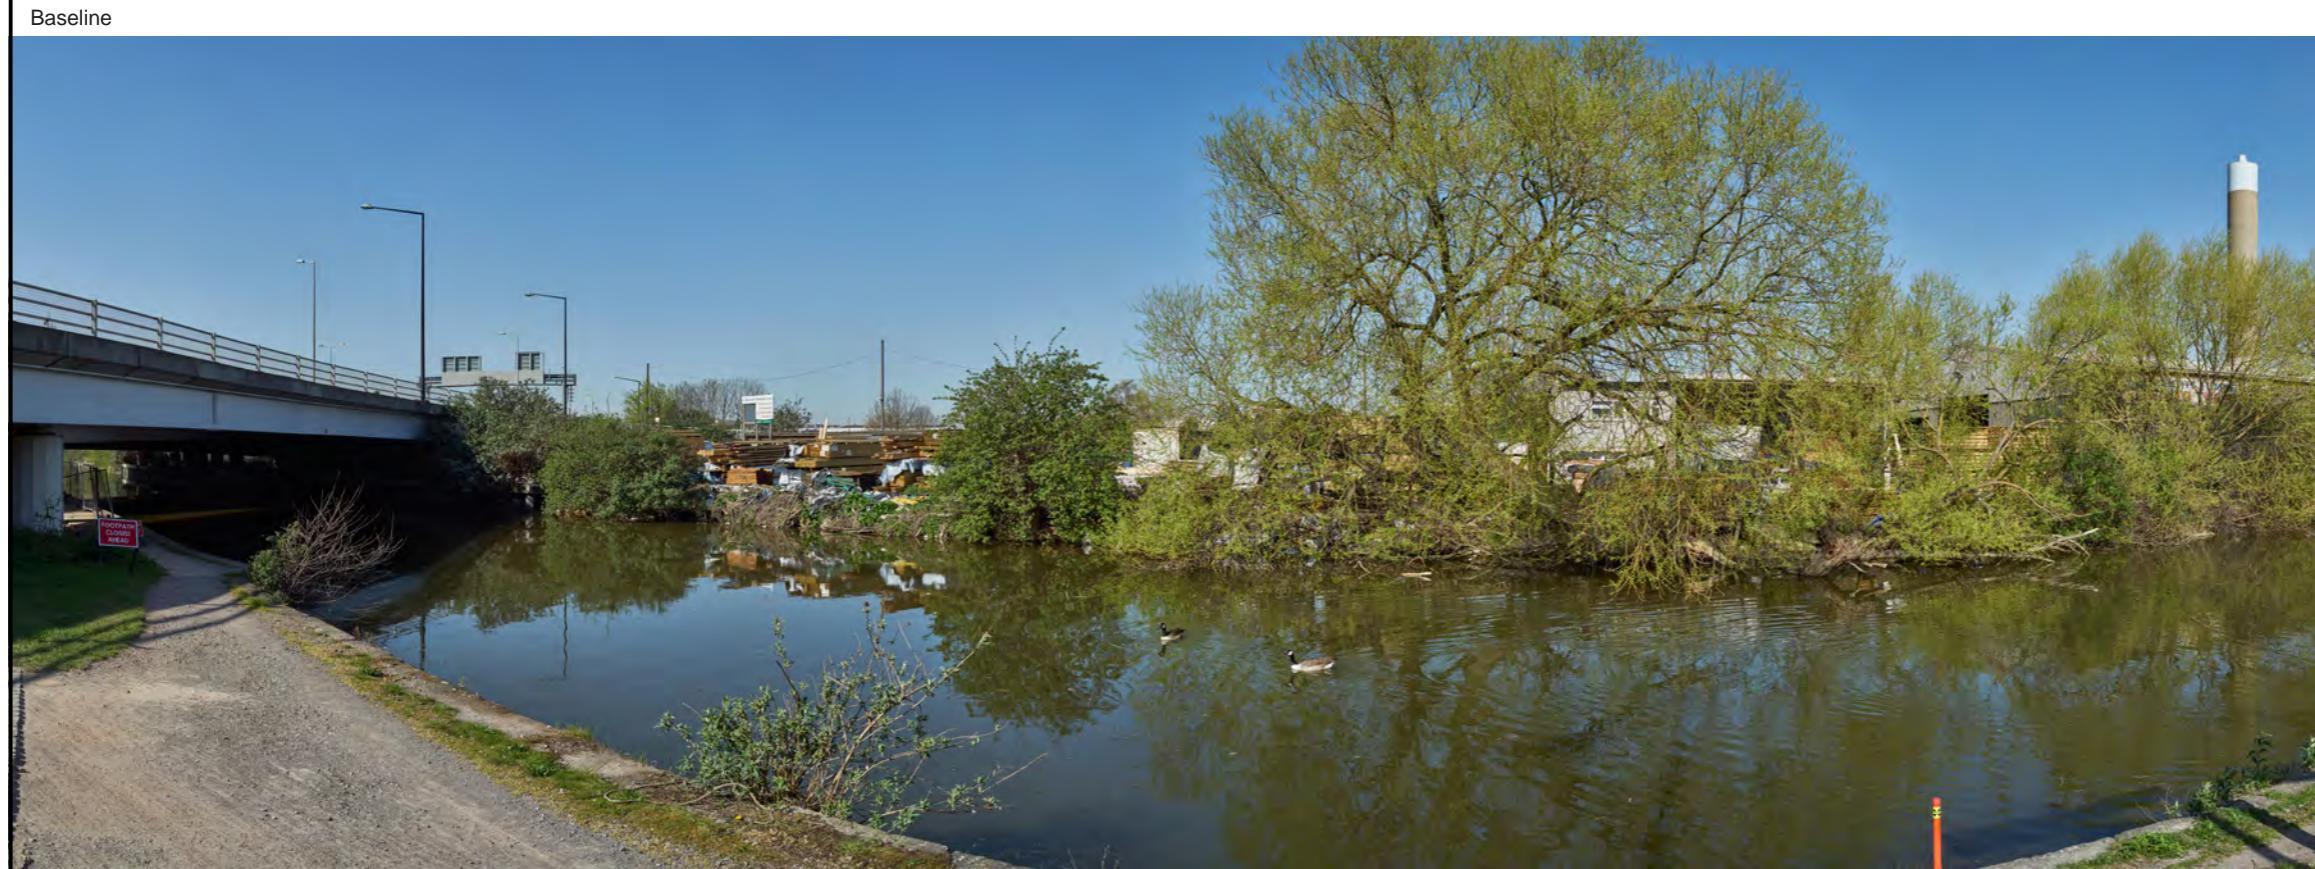
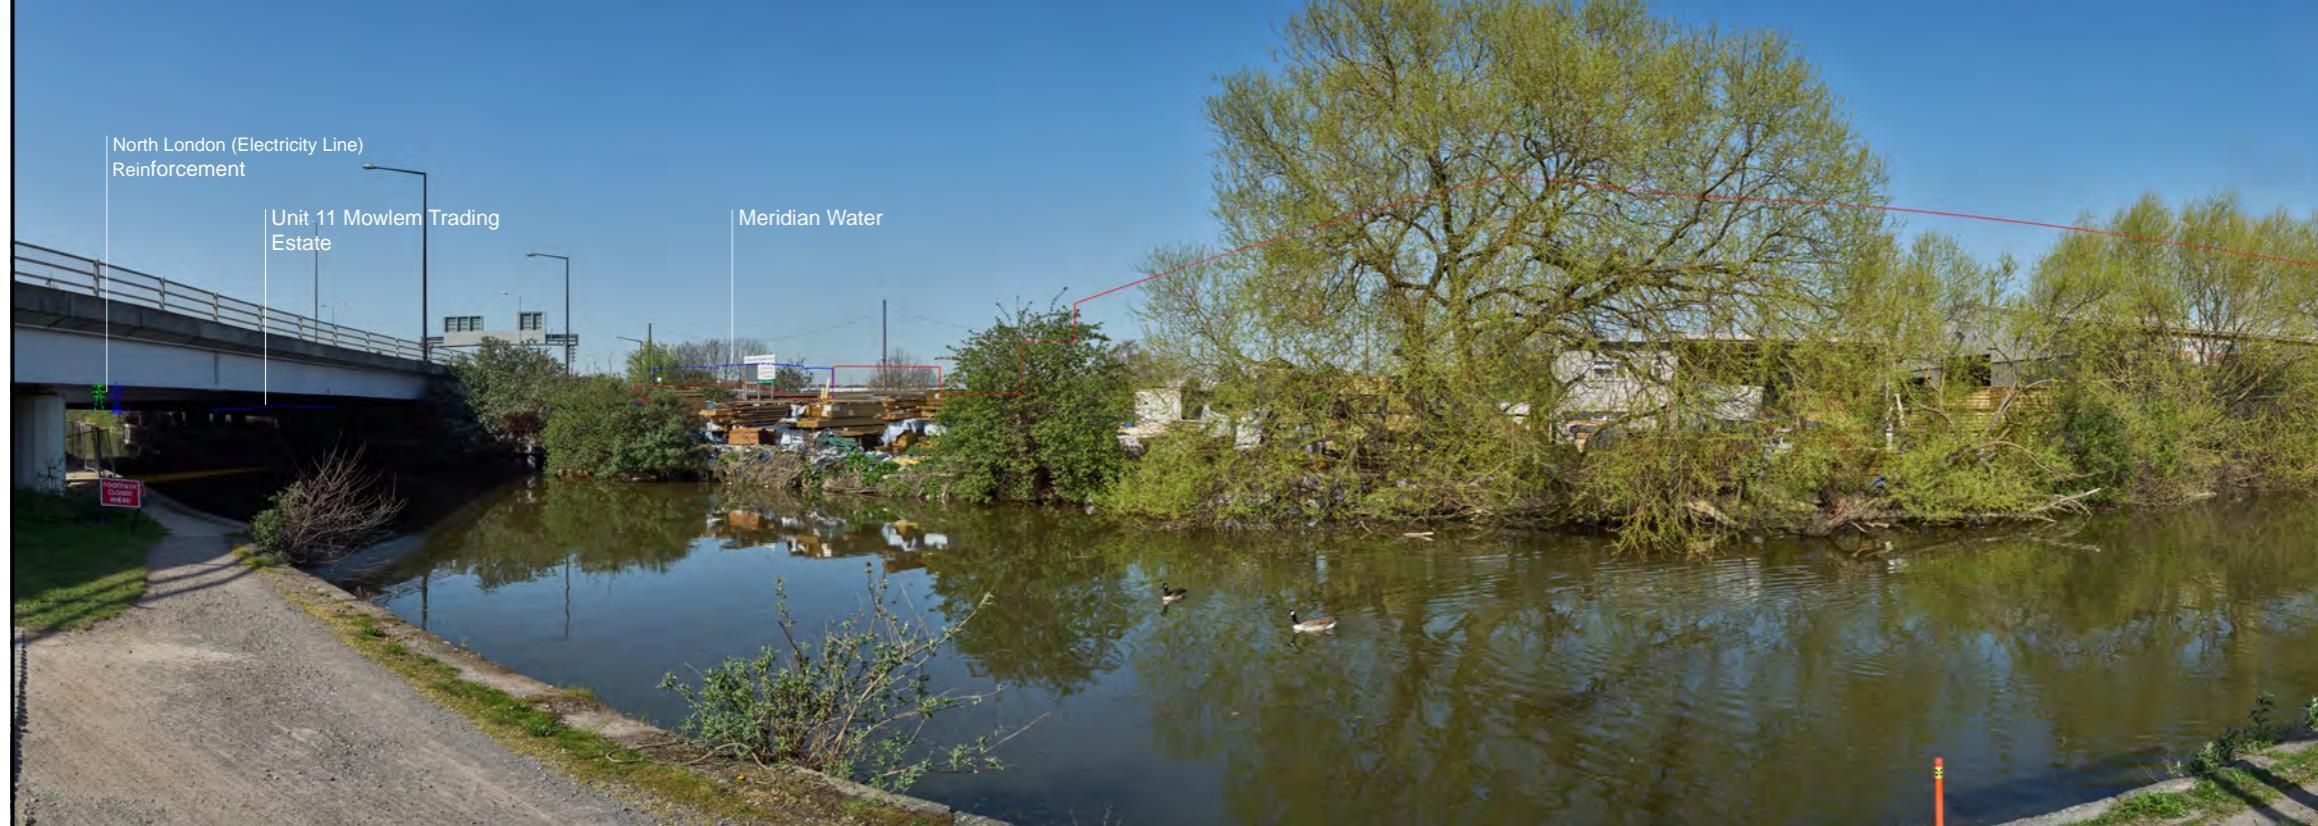
Wireline of Proposed Schemes with existing EfW facility demolished

Technical Information Grid Ref.: 535850, 192349 Date taken: 15/04/15

Time taken: 11:31 GTM
