NORTH LONDON WASTE AUTHORITY NORTH LONDON HEAT AND POWER PROJECT

ENVIRONMENTAL STATEMENT: VOLUME 3 APPENDICES

VISUAL ASSESSMENT METHODOLOGY

VOLUME 3 APPENDIX 1.1

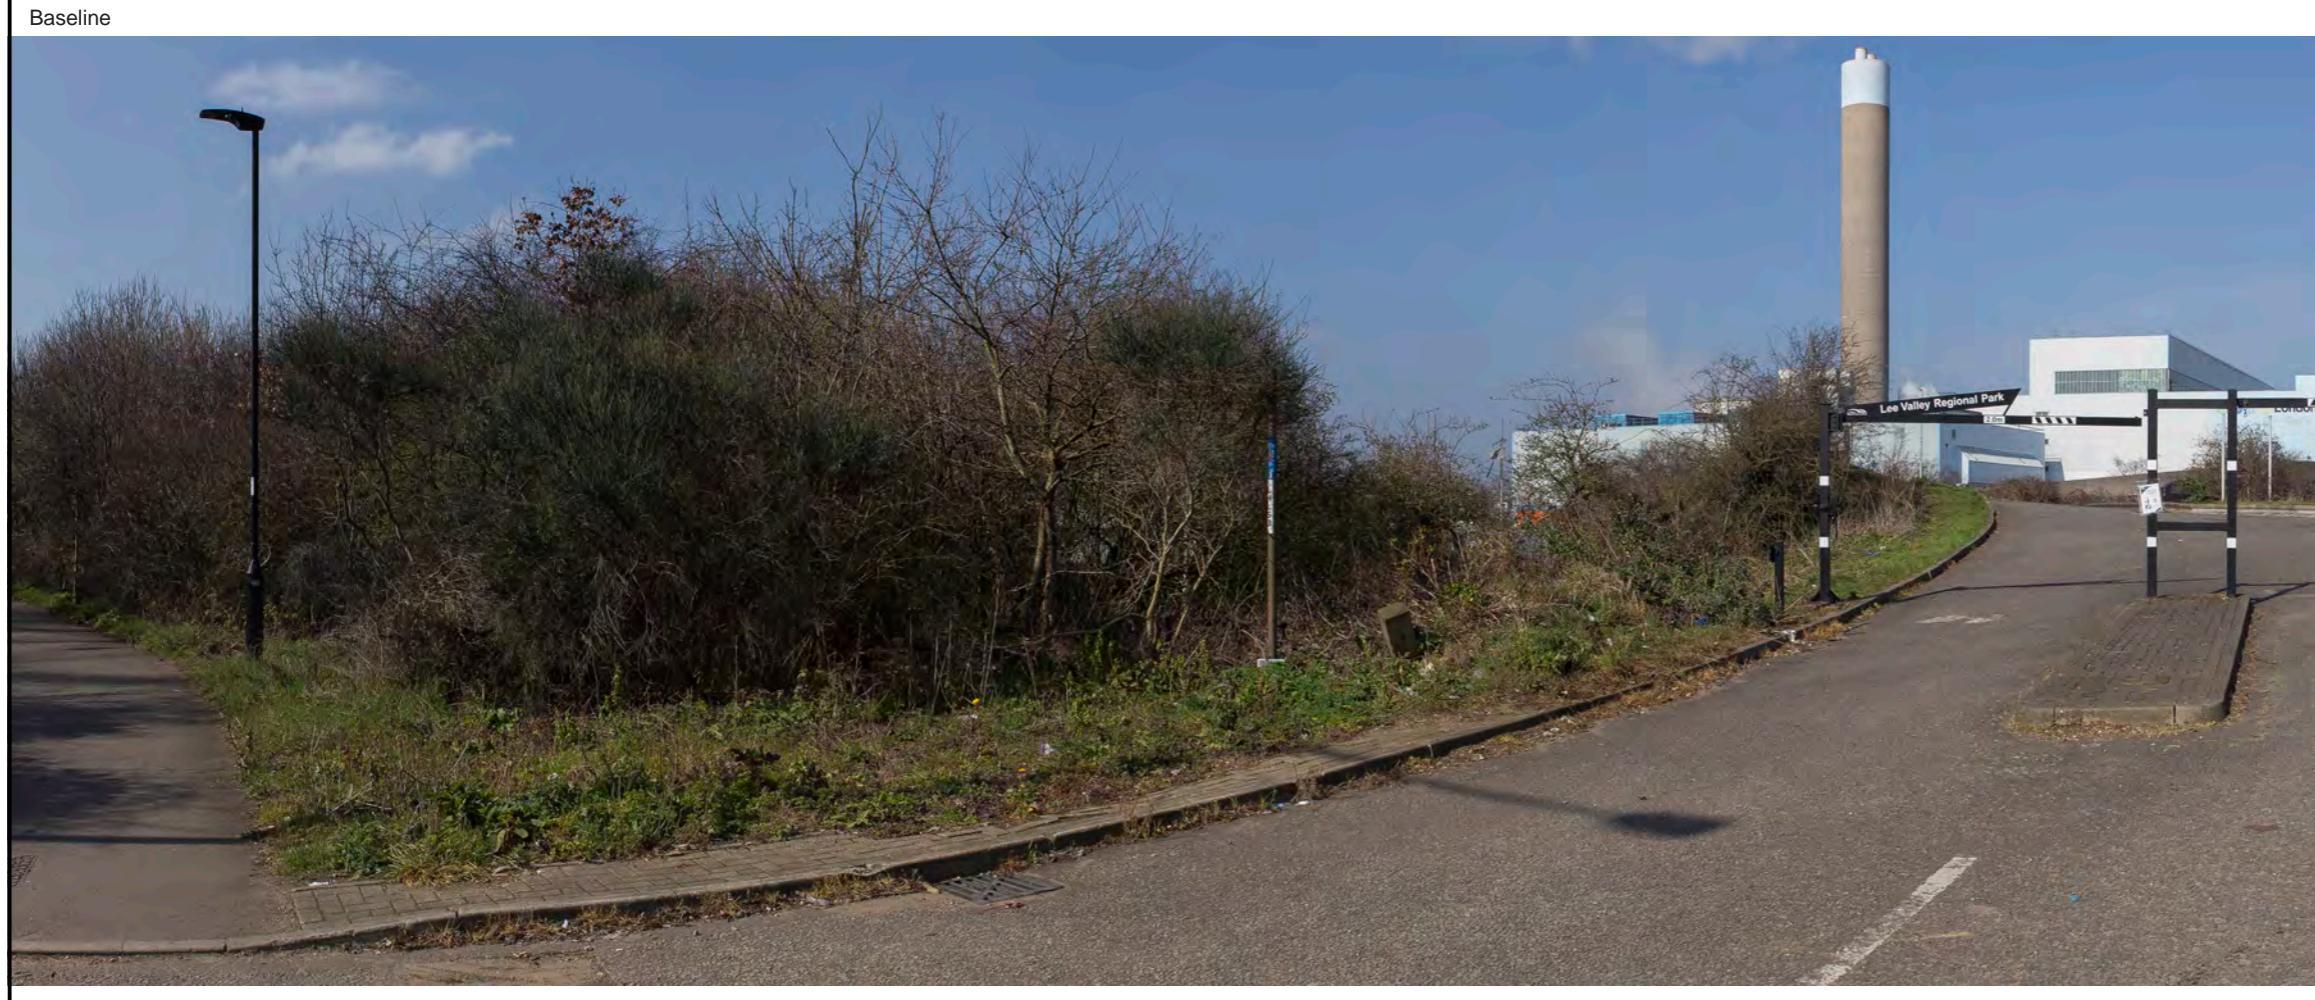
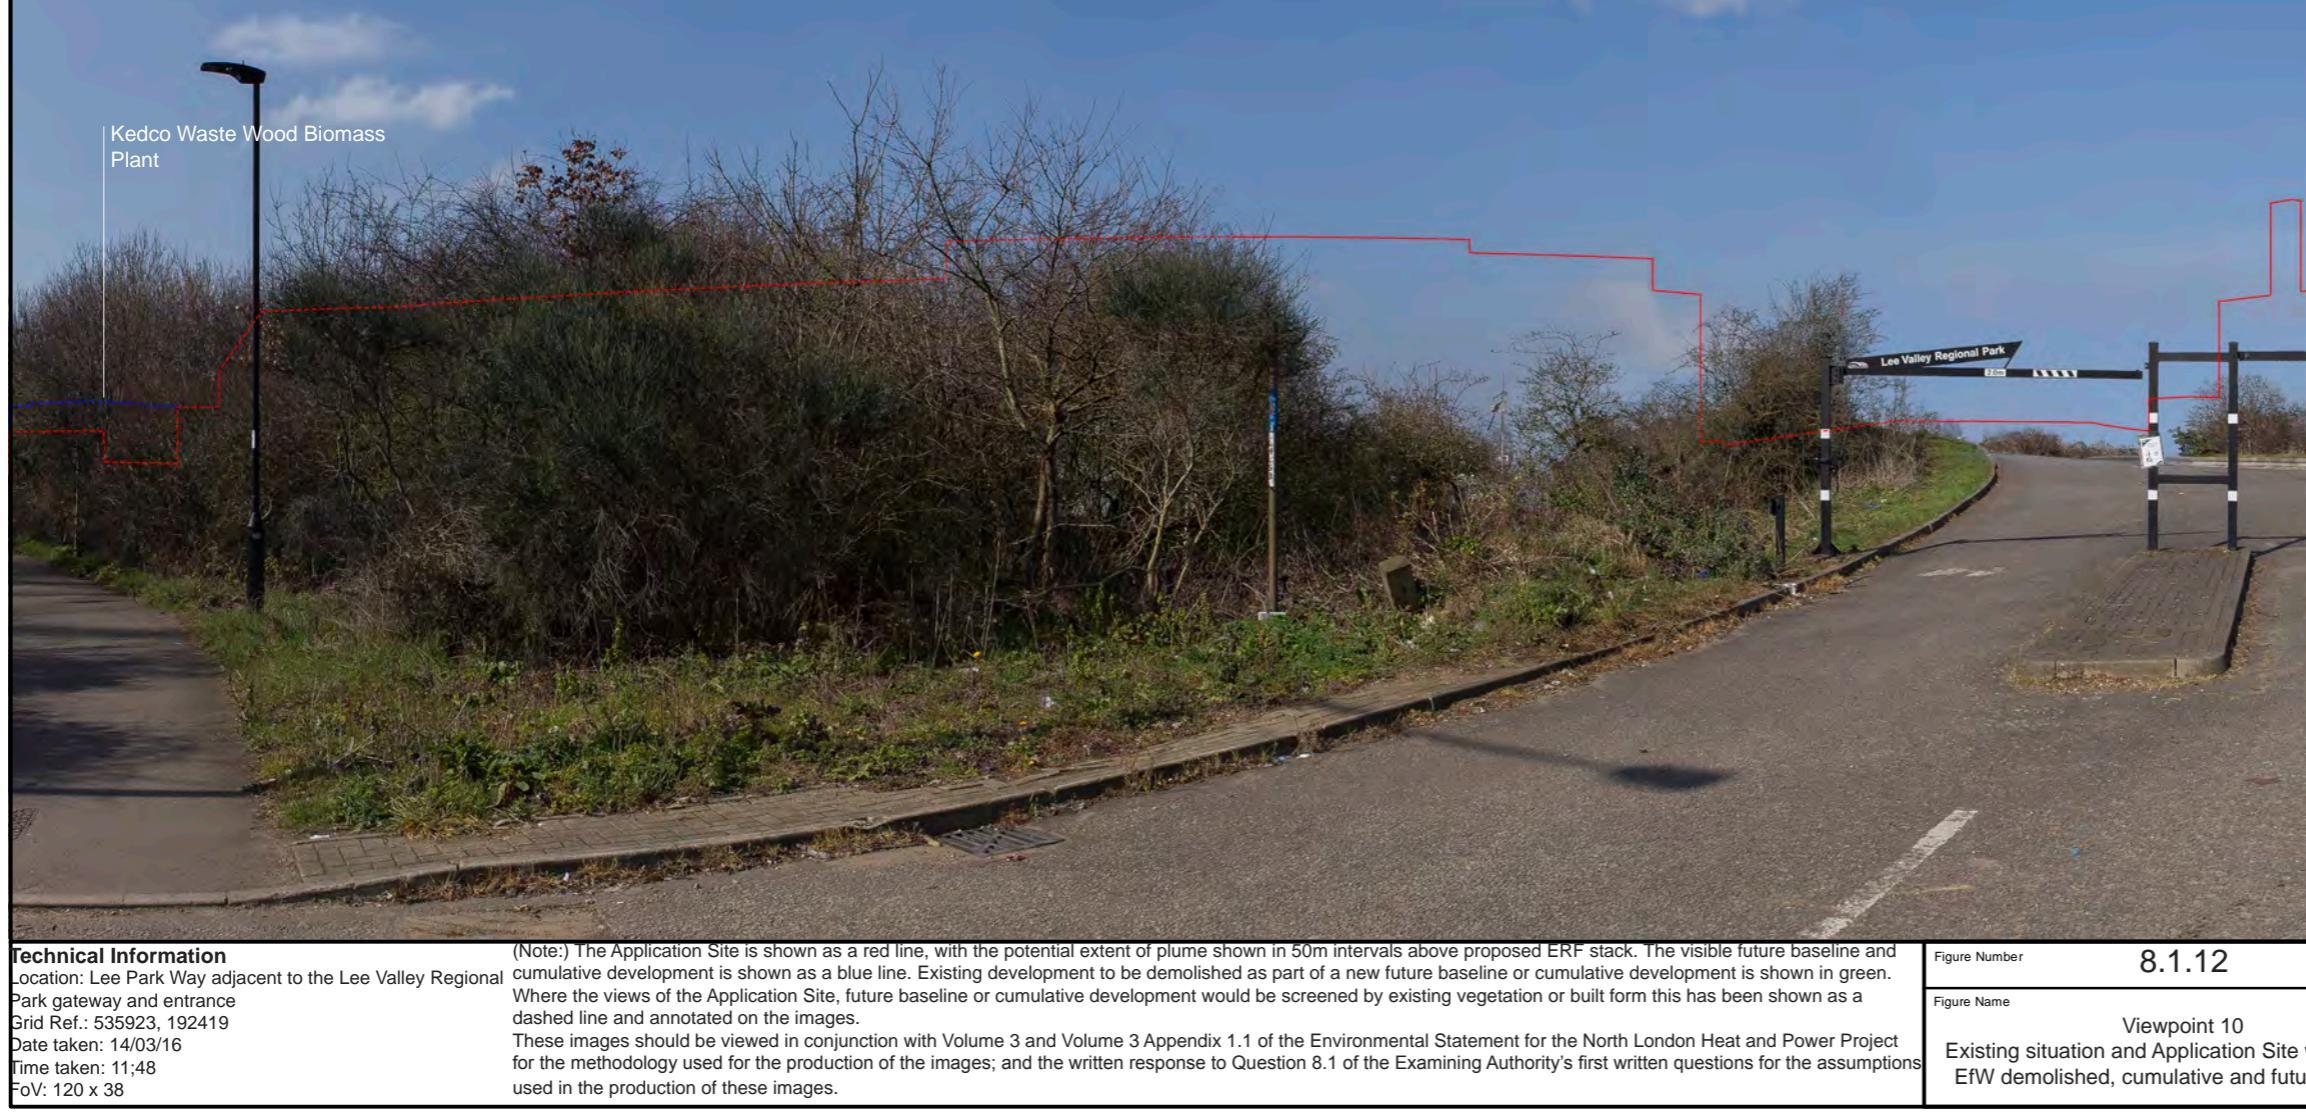
Viewpoint 10 Existing situation and Application Site with existing EfW demolished, cumulative and future baseline

Wireline of Proposed Schemes with existing EfW facility demolished
